TOP FIVE CLAIMS

AGAINST HOME INSPECTORS

PRESENTED BY Carrie Joubert

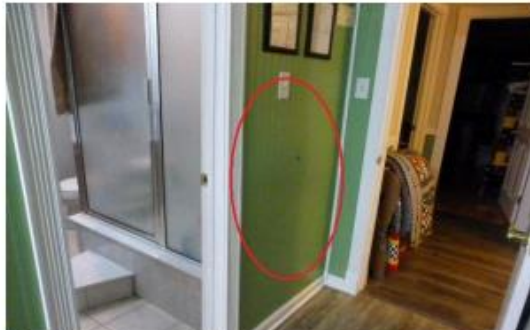
The wall adjacent to the master bath has a visible bulge which should be explained and monitored.

Wall bulging adjacent to master bath shower

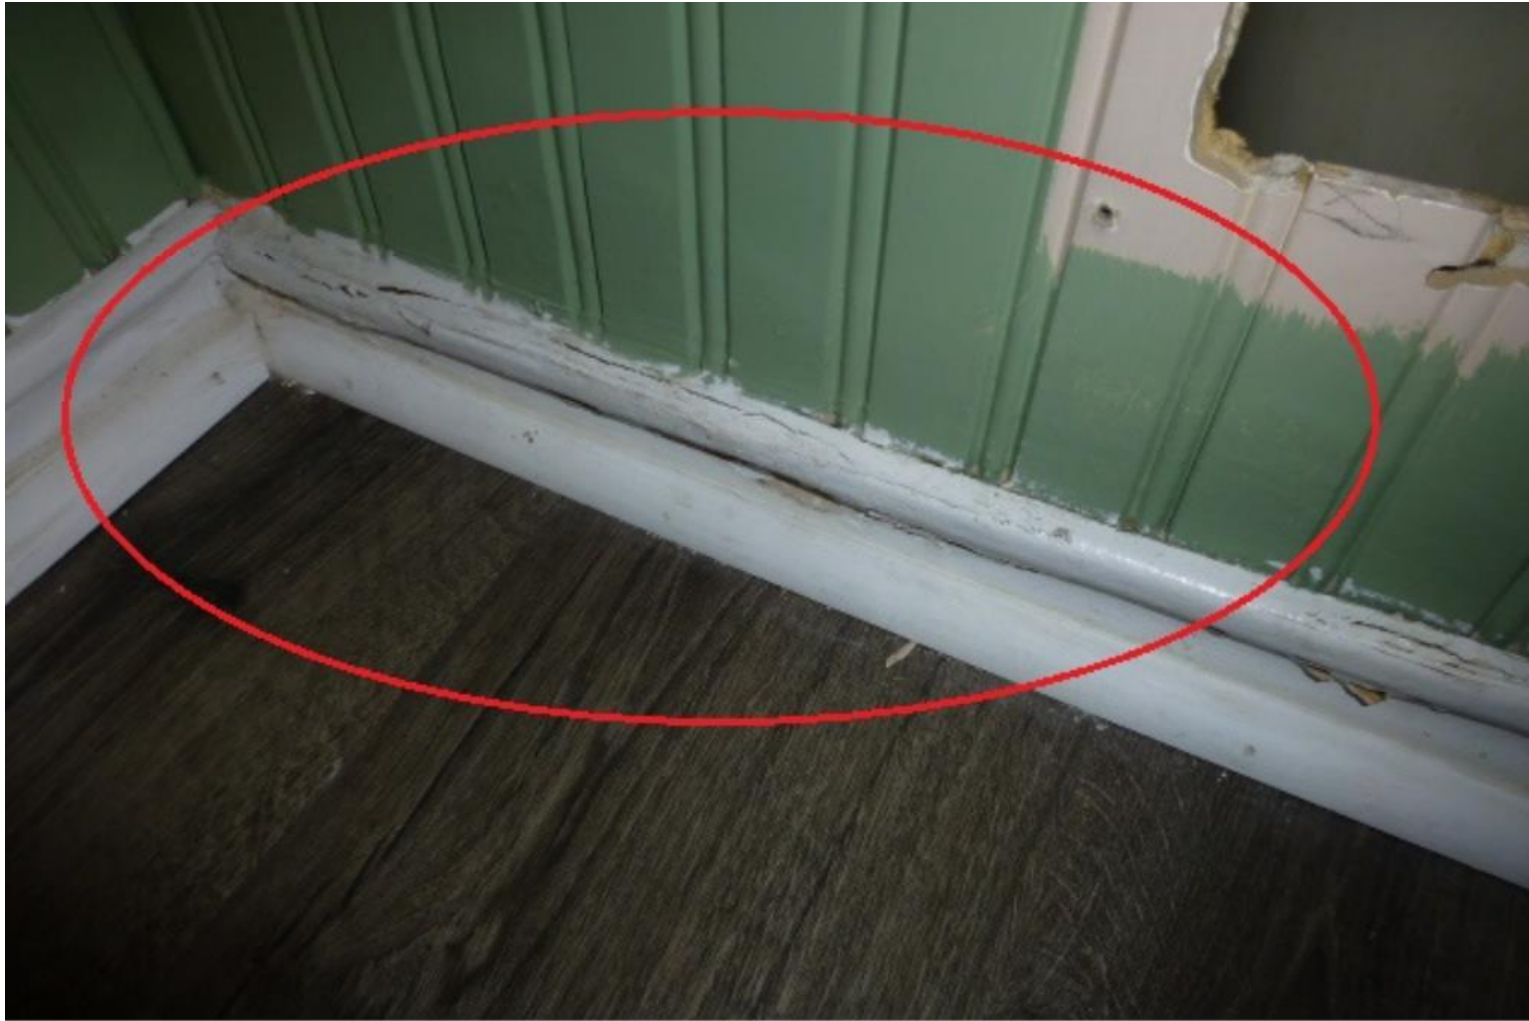
Moisture damage trim and wall in hall area

- Arriving I found visible moisture damaged wood wall and trim in the hall. The moisture damaged trim was visibly cracked and appeared to be a problem that had been ongoing for some time. I did not open the inspection port during the initial inspection because the port was blocked/hidden by a blanket rack which was placed in front of the port. The trim in the wall appeared to have been heavily caulked and painted.
- After evaluating the area and the shower, I determined that the problem appeared to be the shower drain leaking and causing the plywood below the drain to become soaked and moisture damaged.

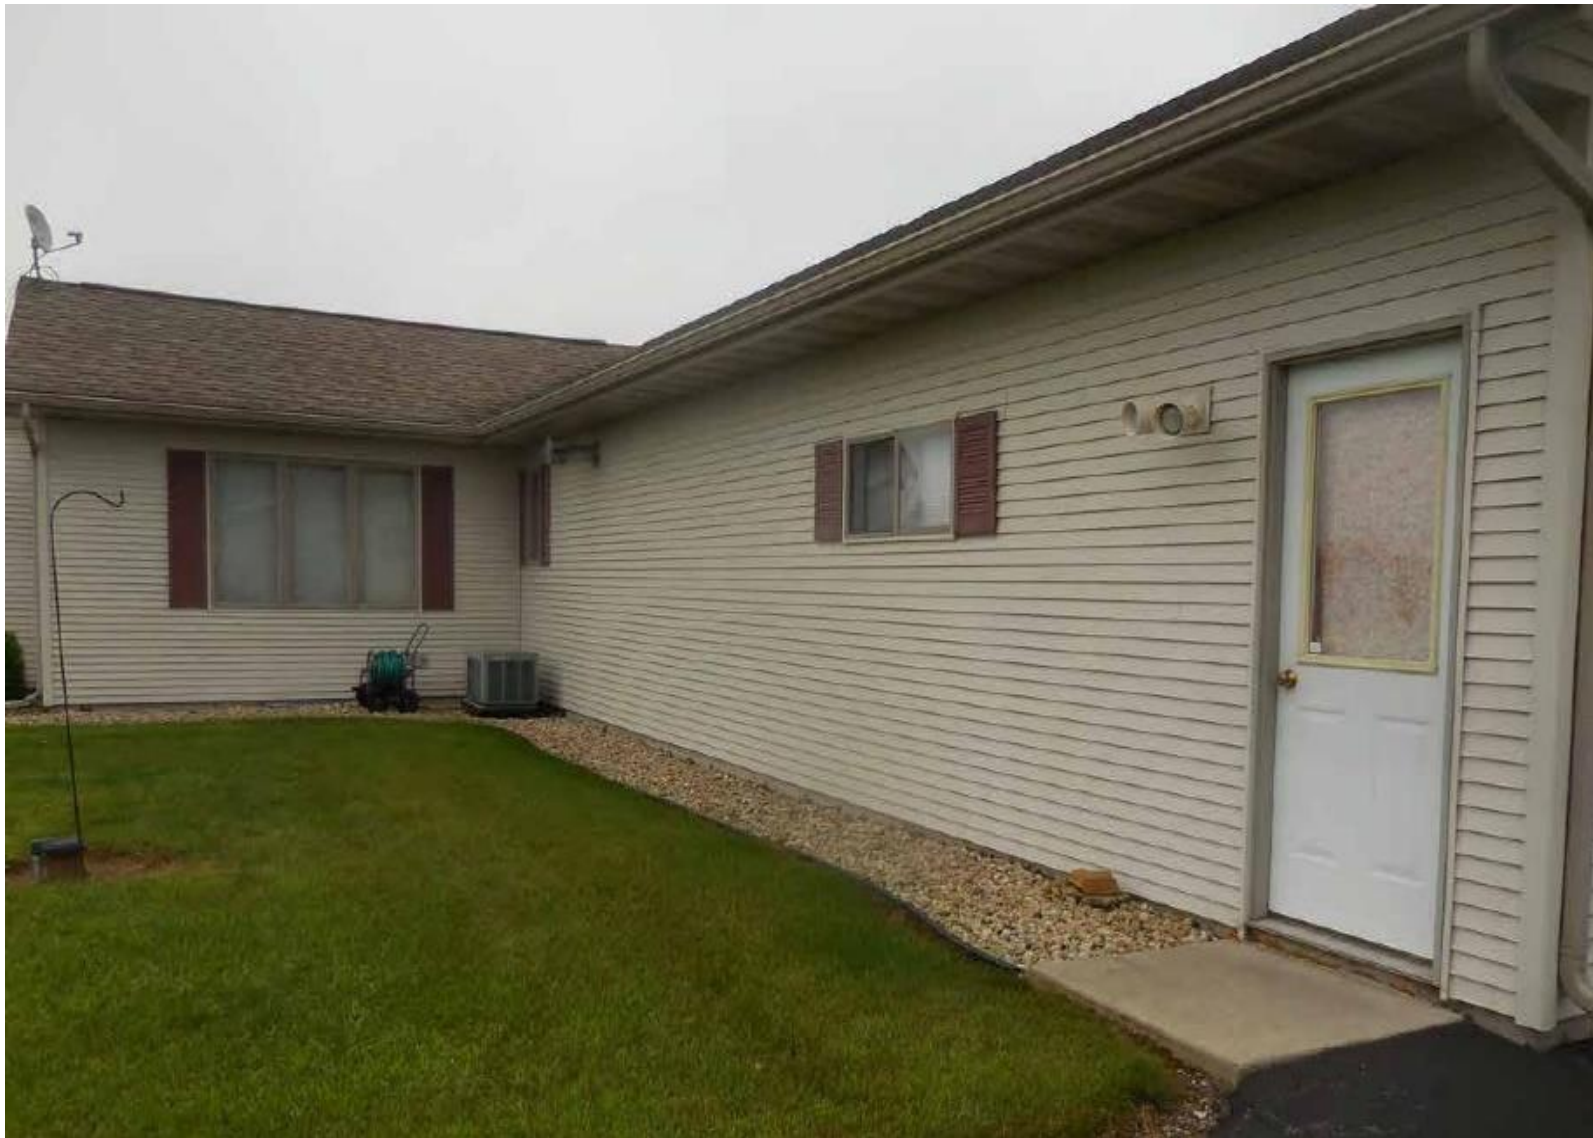
Over a year after the inspection, claimants alleged that the home inspector failed to report significant defects in the property's front stoop. Since the inspection, water had entered the basement between the front porch and the vinyl siding, causing damage. By the time the inspector received the letter, the claimants had already removed and replaced the stoop.

The construction company that repaired the stoop wrote a 5 page letter on the claimants' behalf arguing that the inspector had failed to perform an adequate inspection as he should have noticed the "musty smell." They went on to say that the inspector *photographed but did not call out the water stains* on the exterior siding and that he should have made recommendations to prevent future water intrusion.

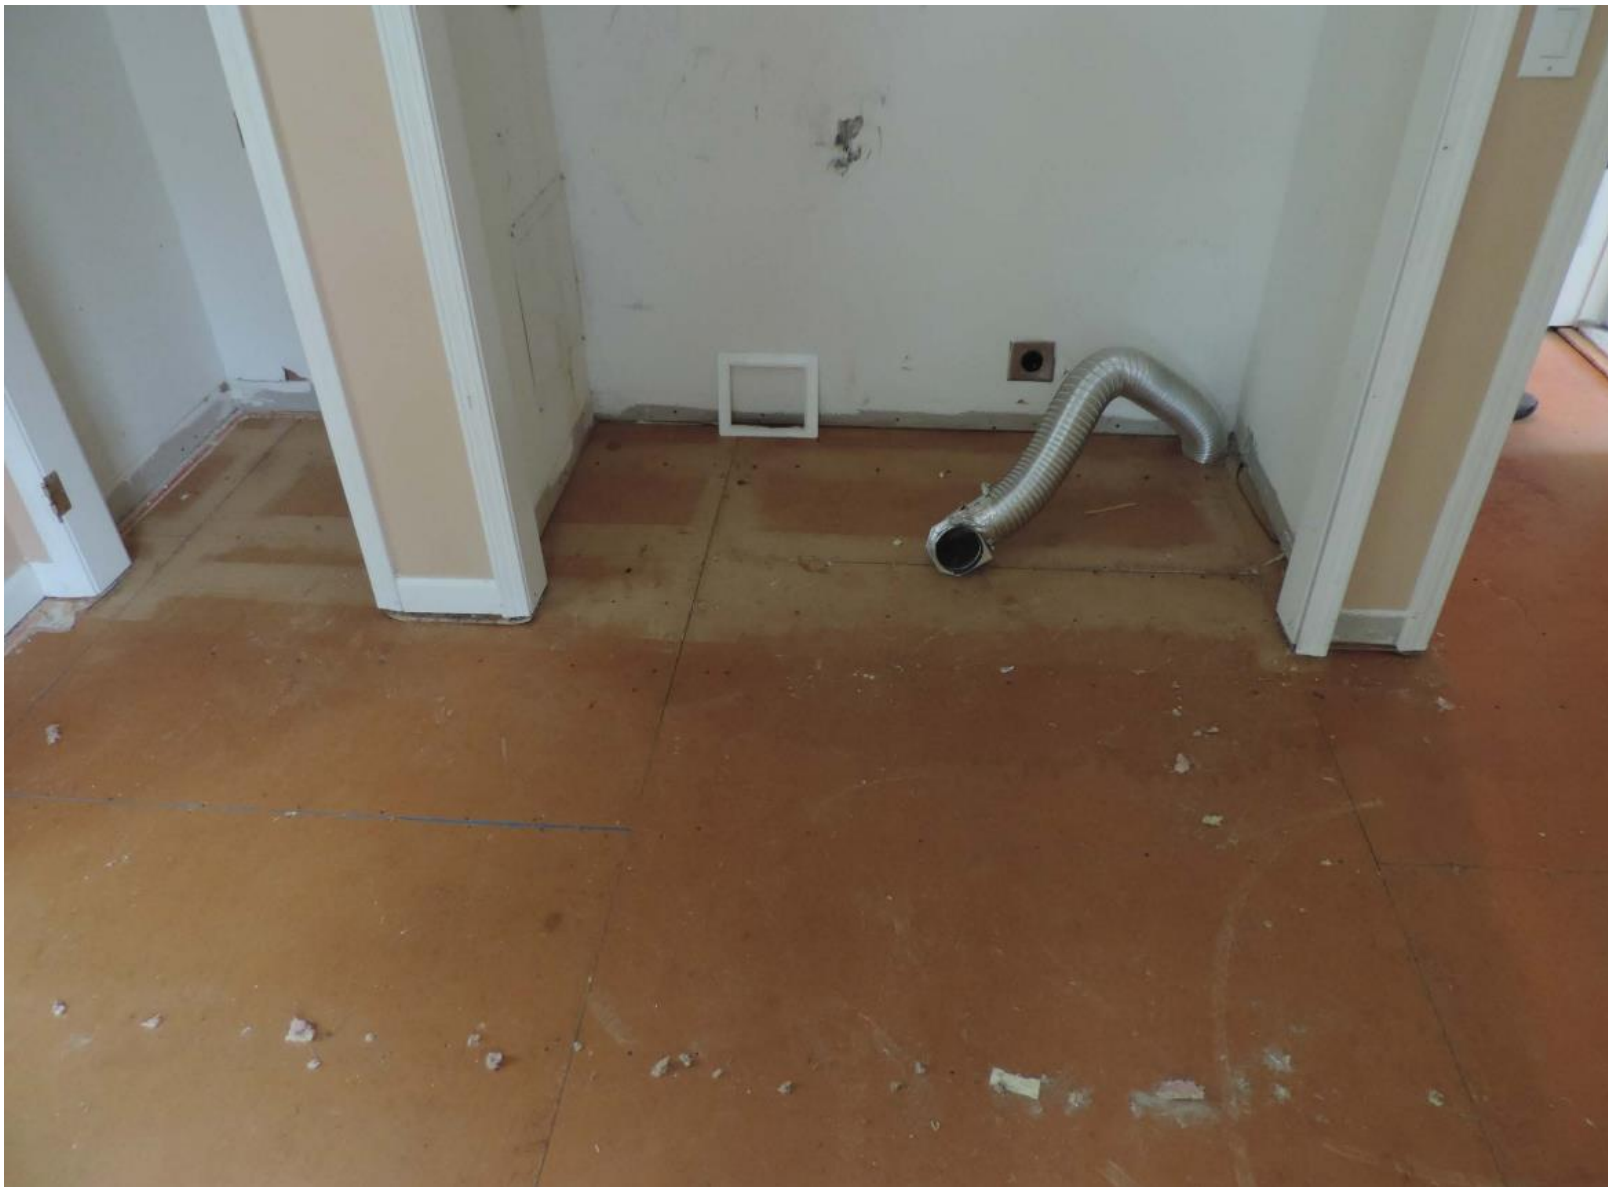
He disconnected the hose.

He admitted that he did disconnect the hose and that he may not have reattached it correctly.

Water damage like this is certainly the most common GL claim. It often comes from leaving a tub running.

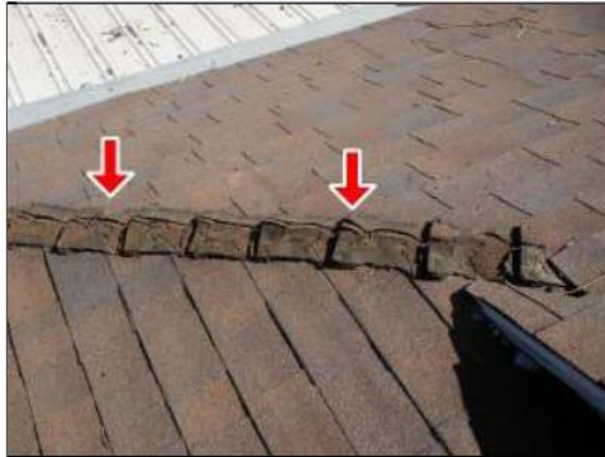
3.2 Item 1(Picture)

Inspection indicated that the roof cover was composed of dimensional asphalt shingles with molded ridge cap shingles at the ridge line. The ridge cap shingles are damaged and deteriorated in numerous areas from age and exposure.

It is recommended that further evaluation and estimates for correction of the conditions noted by a qualified roofing contractor occur before the close of the contingency period.

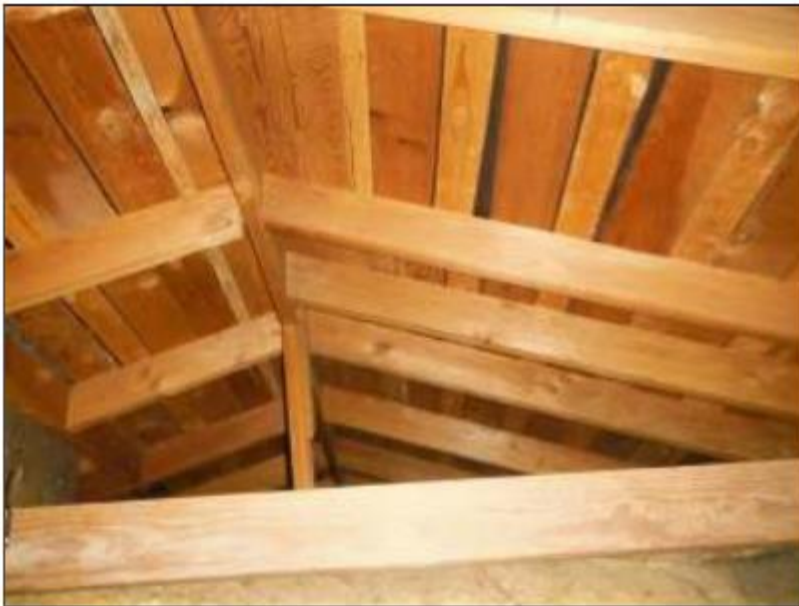
3.9 Item 1(Picture)

(2) The roof support framing is composed of dimensional lumber rafters and solid wood boards installed. Interior purlin wall roof support was noted. No indications of past leaks or stress to the roof support system was observed on the day of the inspection.

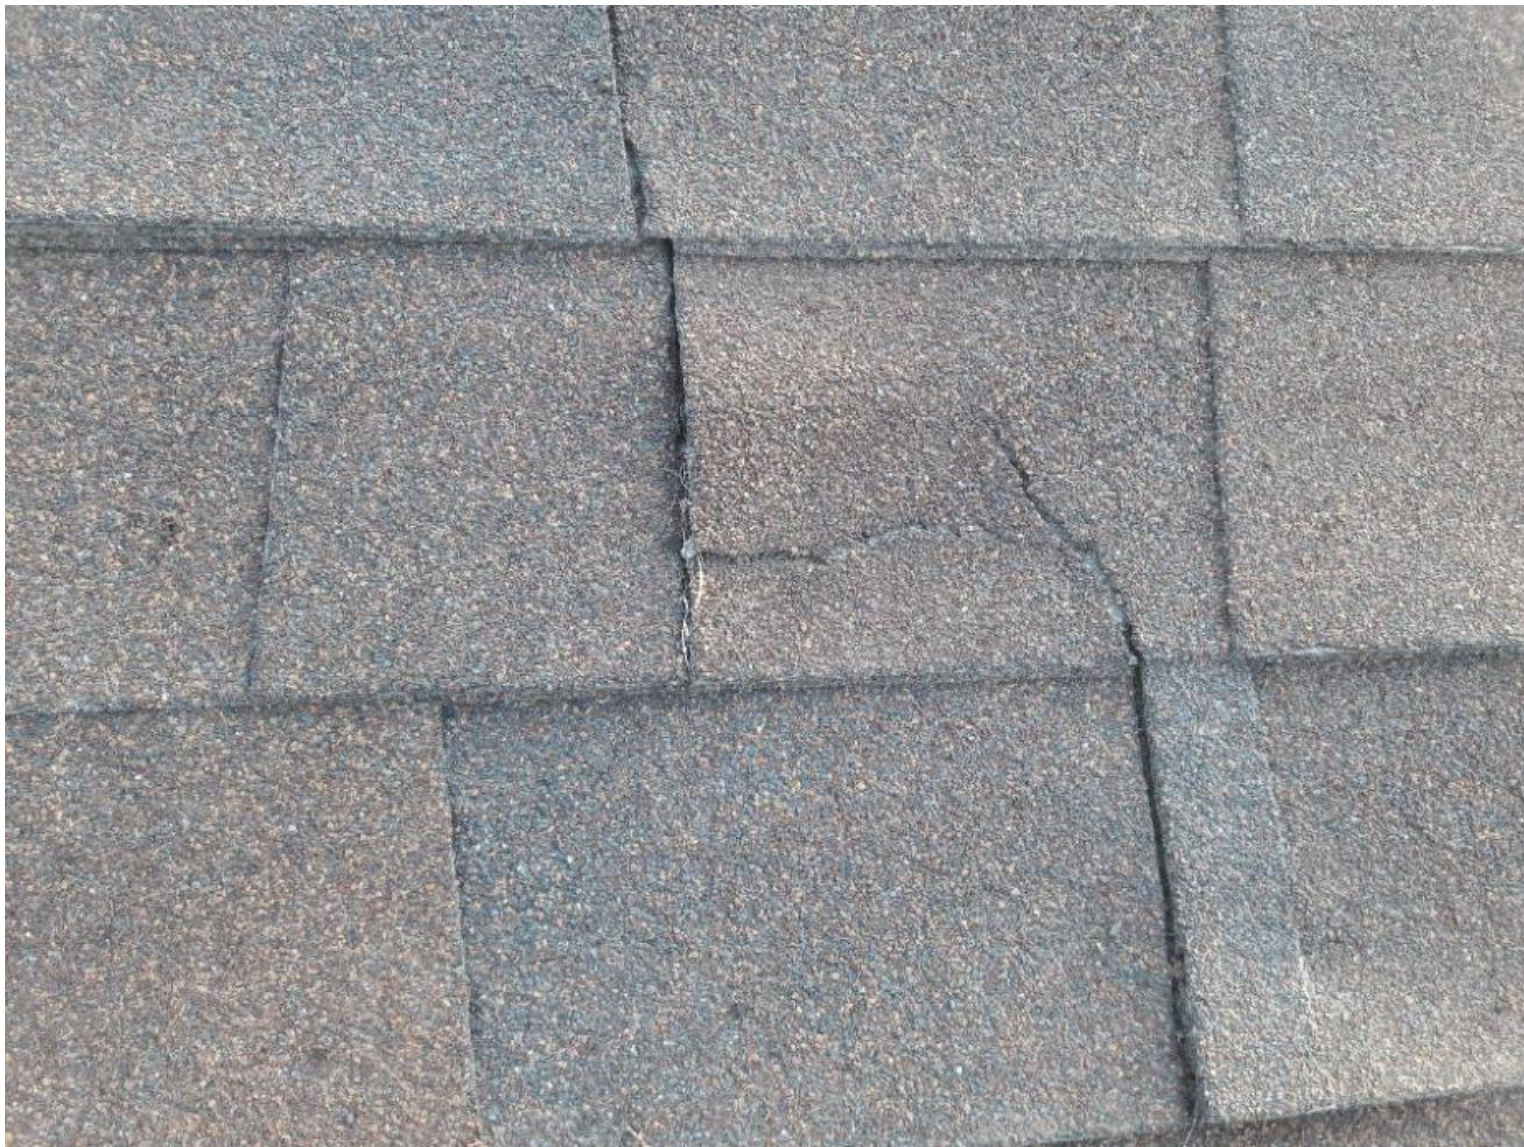
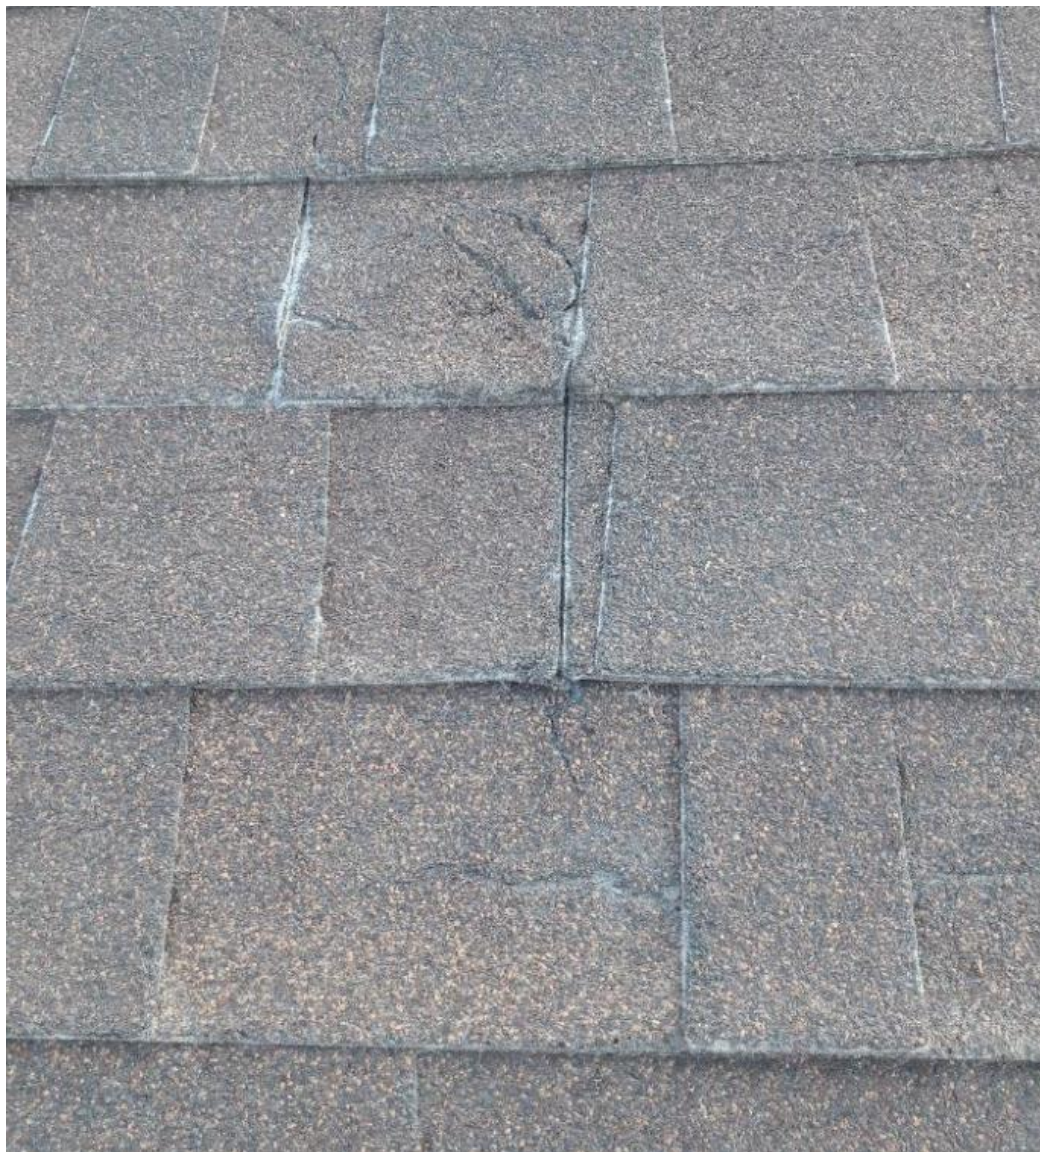
PICS FROM THE CLAIMANT:

On the inspector's birthday, he receives a call from a recent buyer who is experiencing roof leaks 5 months after completing his inspection. They would like the roof replaced.

- Didn't take pictures of some of the damage, claimant found.
- There was also asbestos found in the ceilings (used as a bit of a threat).

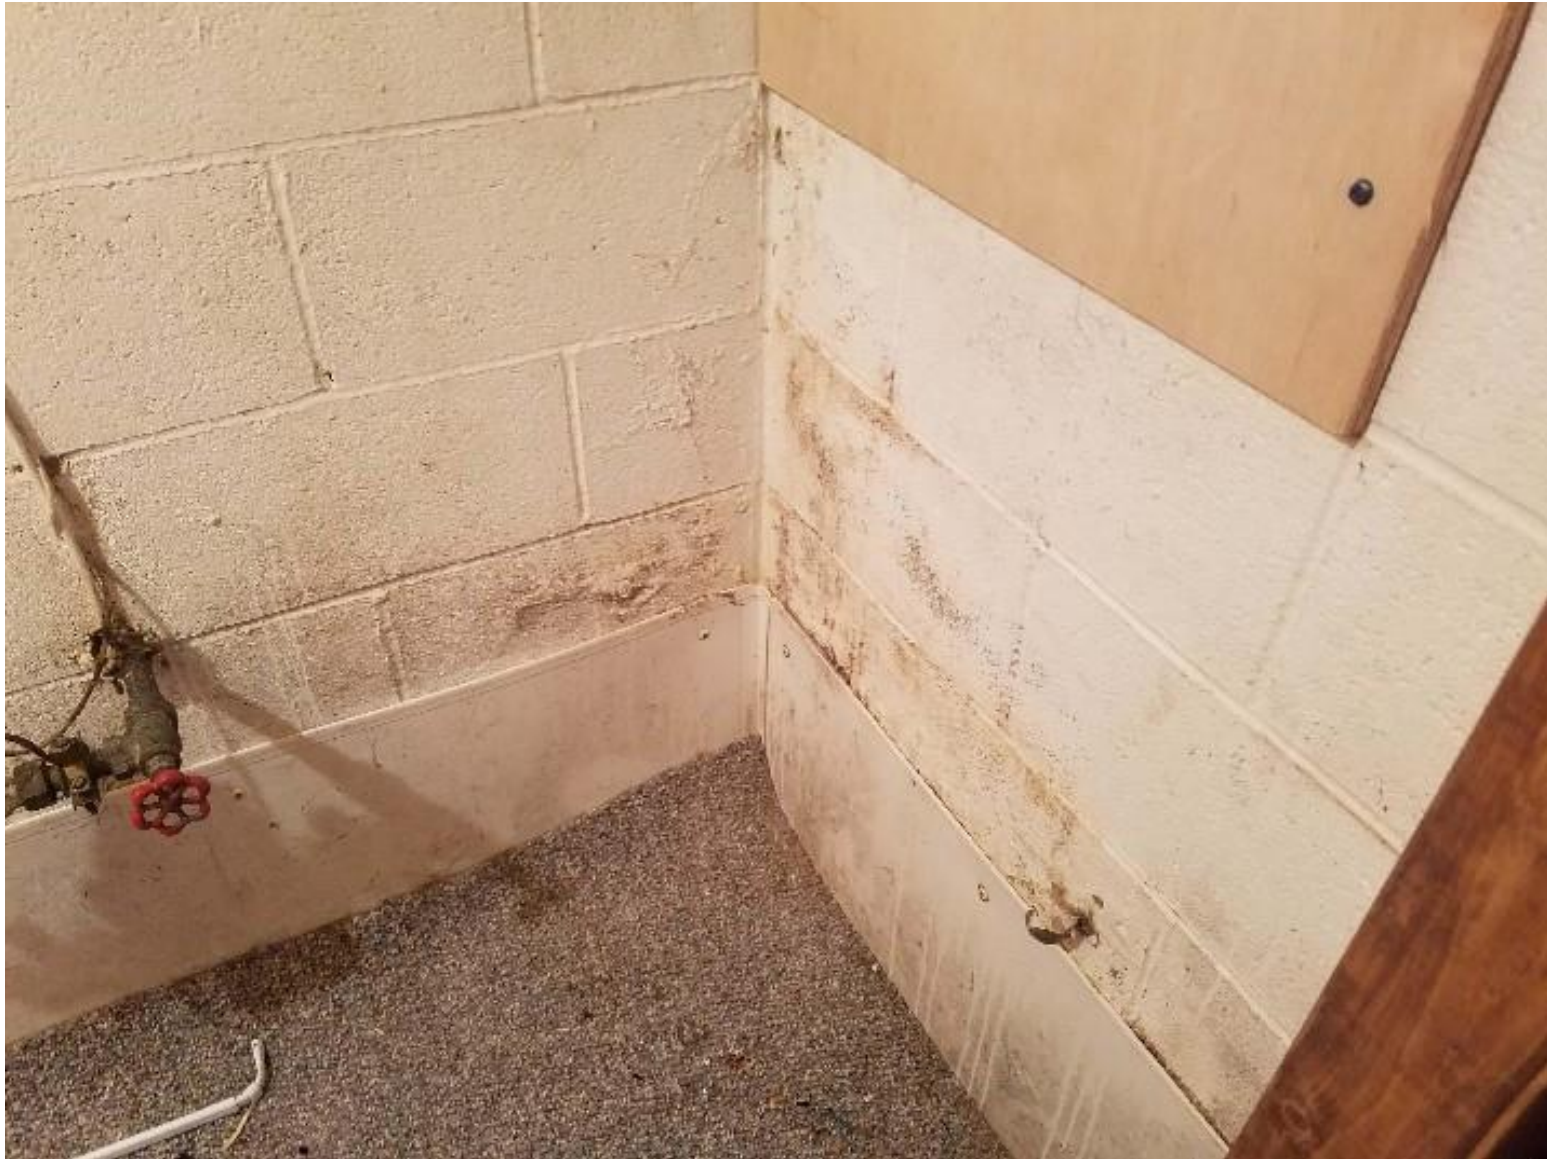
**Picture
provided
in claim**

- **Nothing was recorded in the report because the inspector didn't inspect for mold.**

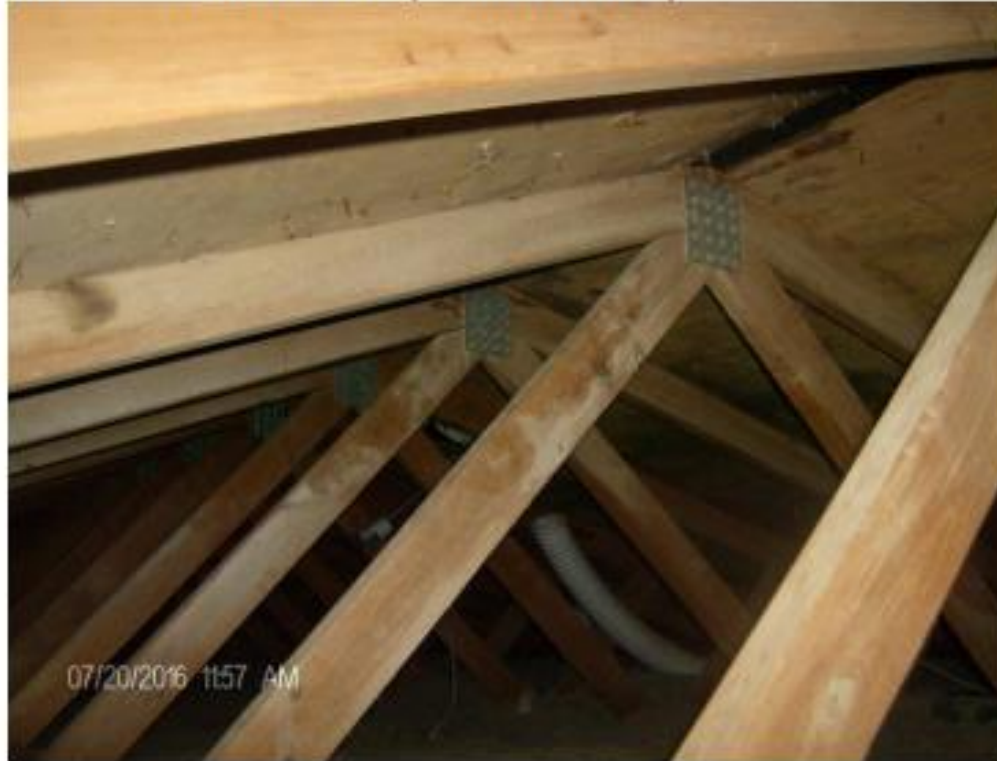
Hall bathroom fan improperly vents into attic. Recommend extending the fans' exhaust to the exterior of attic to prevent damage/deterioration in the attic from moisture/condensation. (Picture follows)

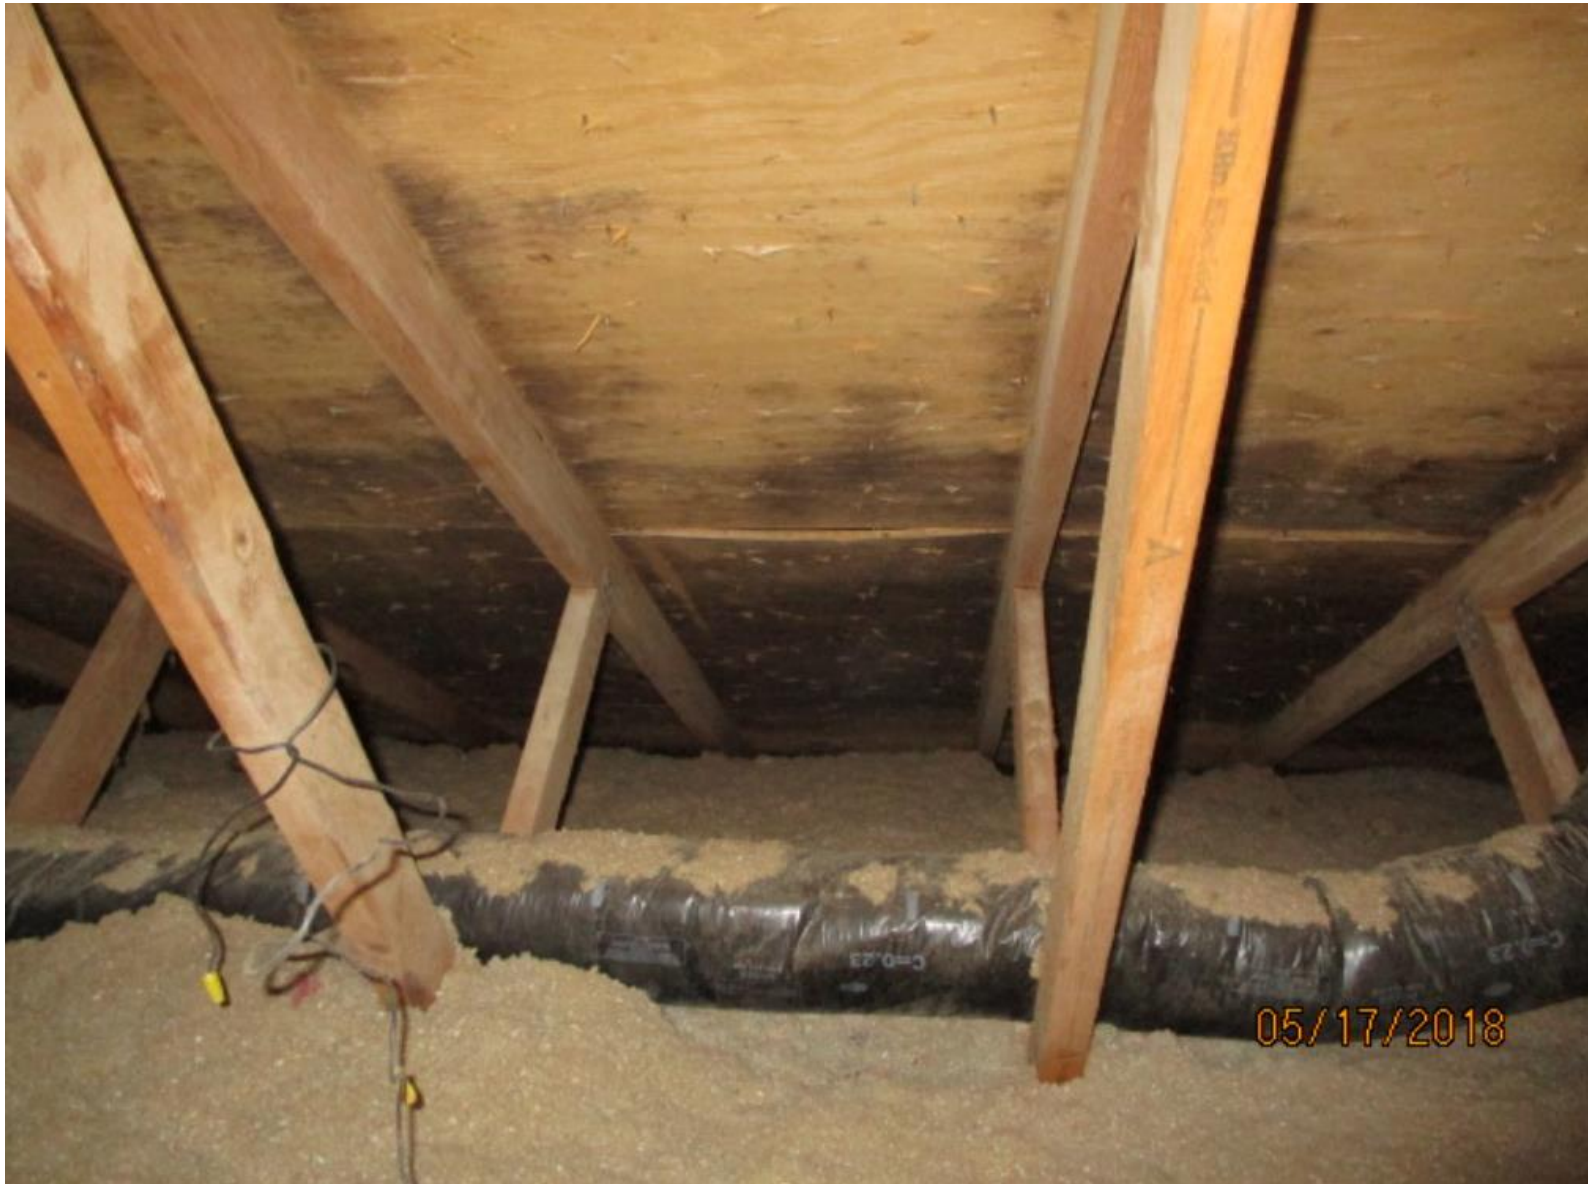
CLAIMANT PHOTOS:

Two years after the inspection, claimants alleged the home inspector failed to identify improper attic ventilation that led to mold growth. Claimants argue \$21,000 in damages to framing materials and insulation.

Inspector excluded mold in his agreement and noted ventilation issues that needed to be corrected. After issuing a Denial of liability letter the claim was closed.

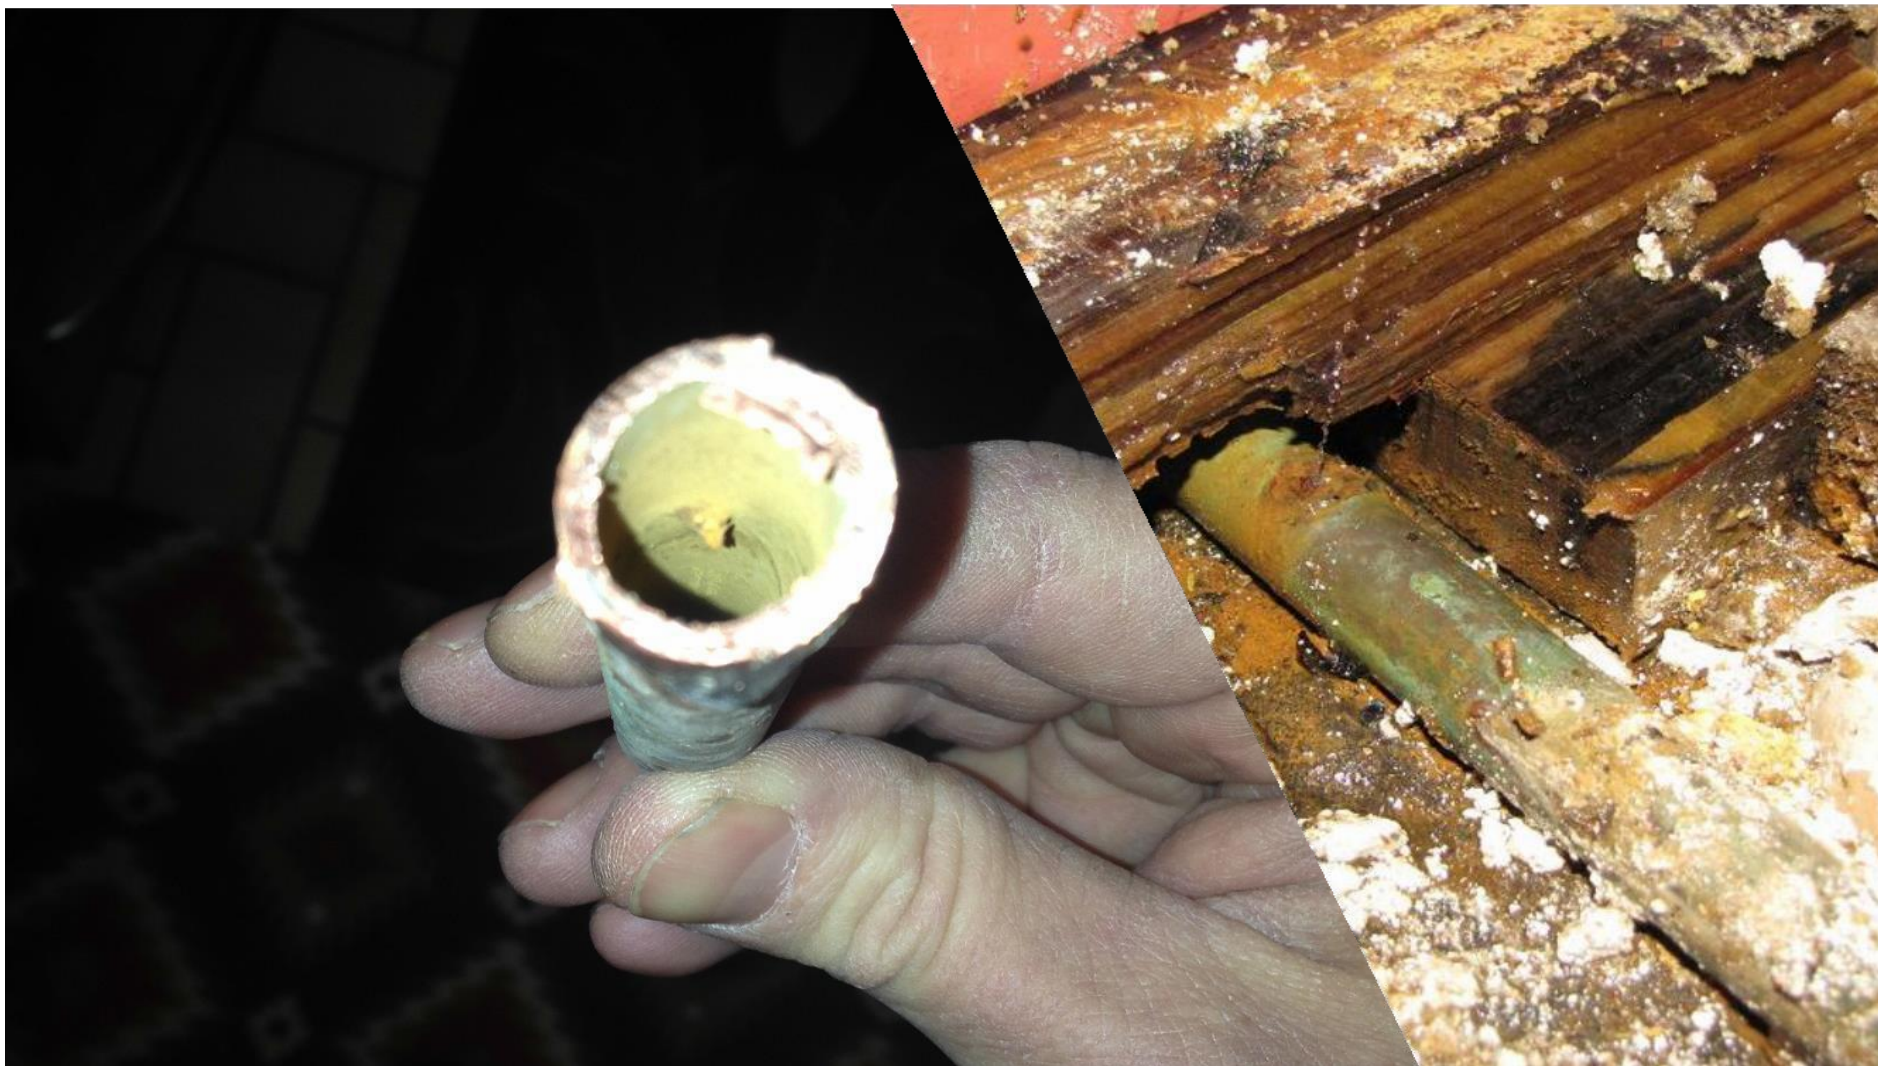
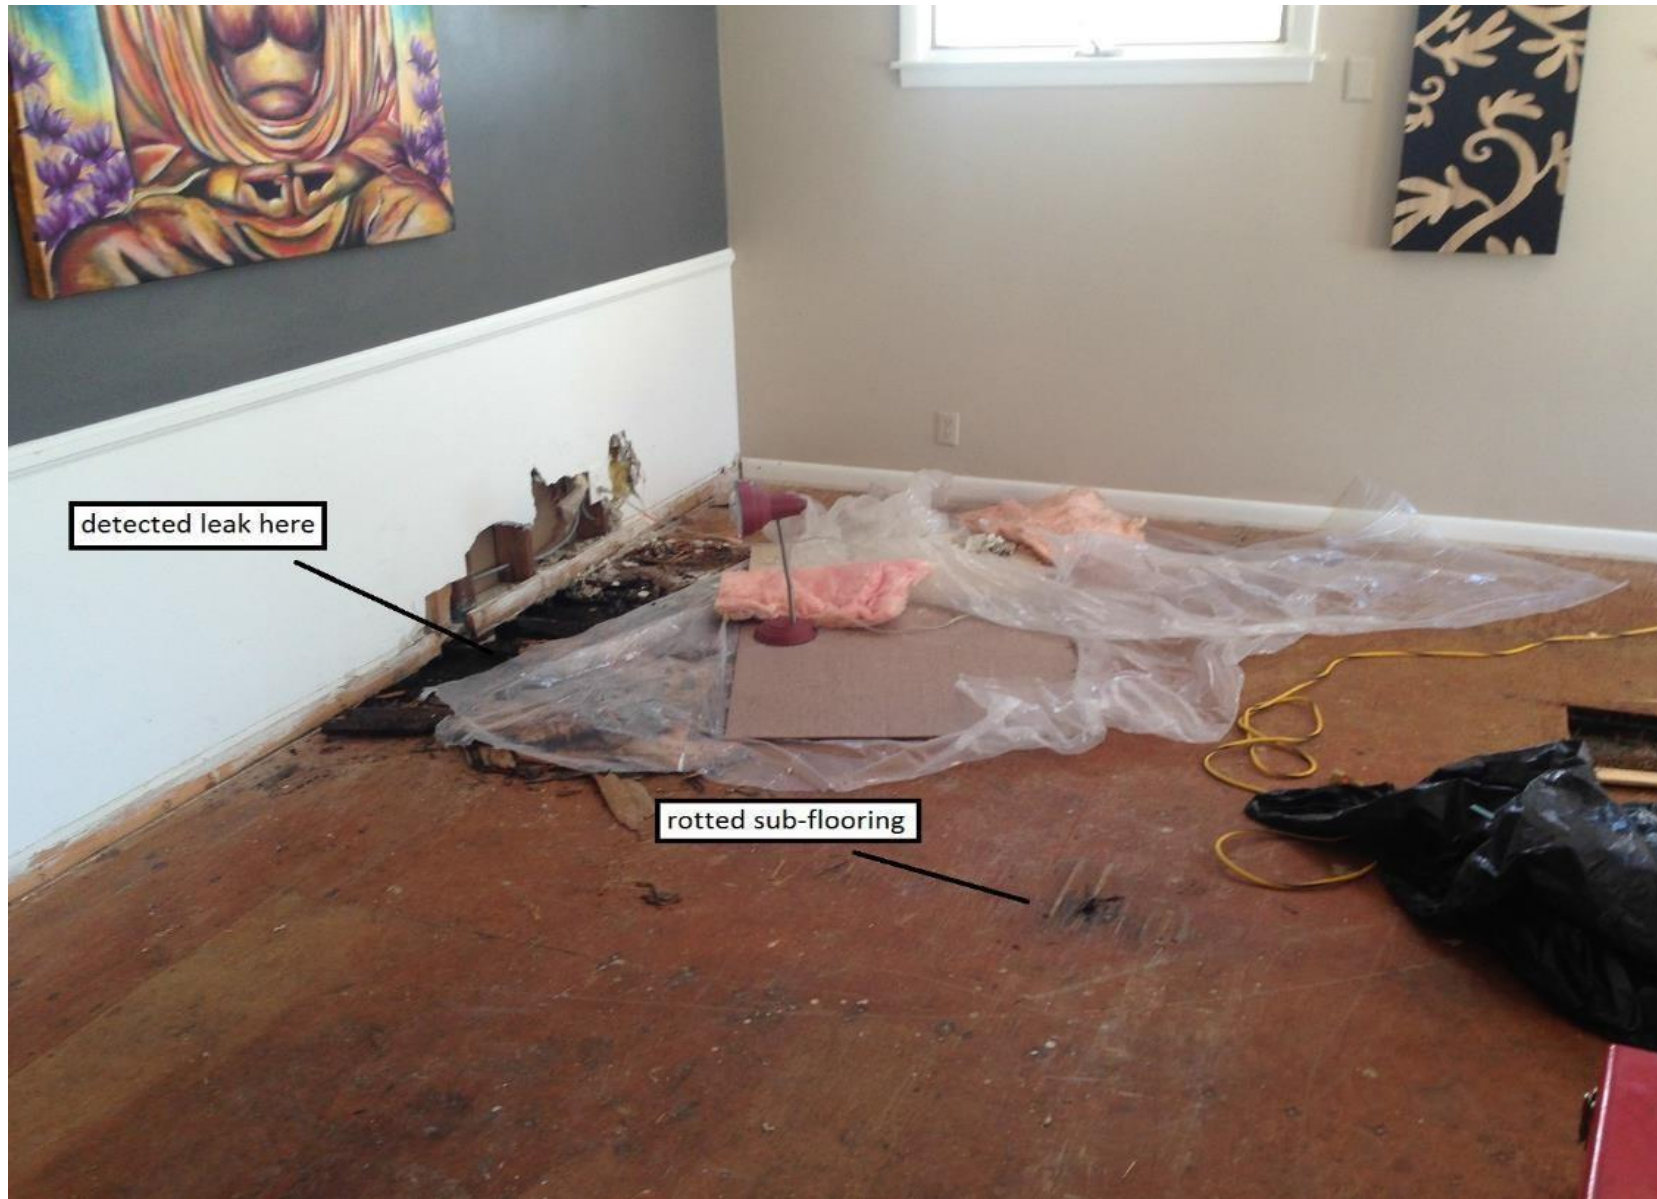
PICTURES PROVIDED OF DAMAGE

A screw was found in a tile in the remodeled bathroom . It had pierced a plumbing pipe under the floor and had been leaking
