Fiber Cement Siding

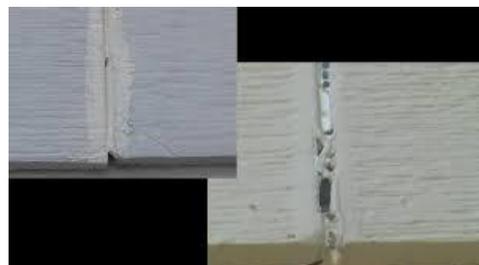
One of the most common defects is gaps at butt joints. Early on caulking butt joints was recommended practice, so early installations will almost always have caulked butt joints. Check this joints as the caulking tends to fail over time and since there usually no flashing behind the butt joint this is an ideal point for water penetration and resulting damage to the wall sheathing. It is acceptable

to use a metal joint flashing in place of caulking. This is a more durable approach but not always used mostly due to cosmetic reasons.

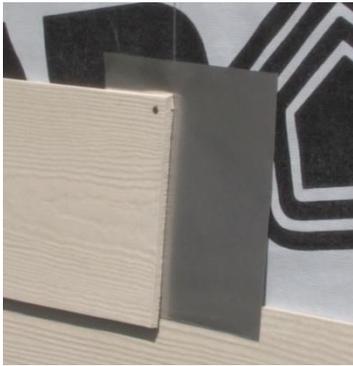
On newer installations you will not see caulked butt joints. Instead flashing is placed behind the joint. Look carefully or insert a small probe to see if the flashing is present. Sometimes you can see the edge of the flashing at the bottom of the siding. From a repair stand point this condition can be corrected and it is possible to install flashing in an existing installation. It is acceptable to re-caulk the joint but this is not desirable as the caulking will fail again, it usually looks bad and painting will be necessary.

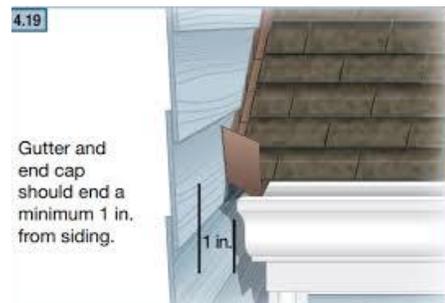
Most installation guidelines recommend spacing the gutter away from the siding and it should not be in direct contact with the siding. This is a common defect as most gutter installers are not familiar with this detail and do not take the time to properly installed the gutter system.

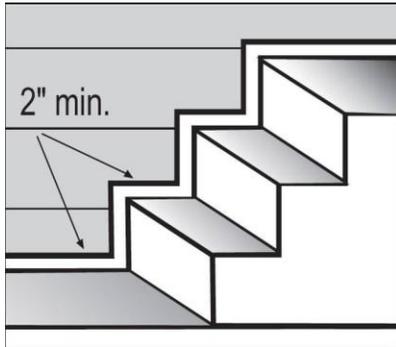
A proper clearance from tops of windows, doors, roofing and other hard surfaces is required to prevent

deterioration of the siding. The requirements changed around 2000 and no longer was caulking of the siding above windows and doors allowed. A proper clearance where the siding meets the roof is essential to allow for replacement of the roof covering and to prevent moisture absorption. Most manufactures recommend a clearance of 1 to 2 inches from concrete porches and stairs. Again this reduces the risk for damage from moisture absorption.

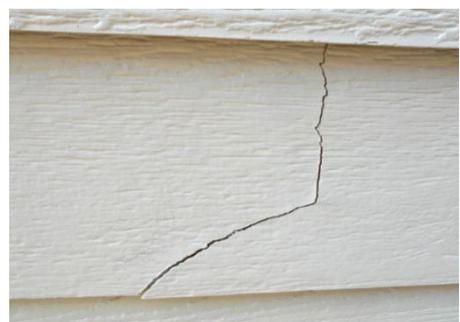
Some fiber cement is susceptible to cracking due to suspected manufacturing defects. If you see random cracking in the open field of siding improper installation is a possible cause but a manufacturing defect could also be at fault. Corner cracking from pin nailing as was previously mentioned may be present. Like so many other situations the inspector must use their best judgement to determine when it represents a concern.

Look for evidence of mechanical damage. Fiber cement is more susceptible to impact damage then other traditional siding types. The best advice when damage is observed is for replacement of that section of siding as most repair methods are considered temporary and will eventually fail.
